Monitoring Data RecordProject Title: B-3157 (Michael's Branch Site) COE Action ID: 200020843WQC Number: 3467Stream Name: Michael's BranchCity, County and other Location Information: Davidson County, Bridge #74 & #76 over
SR 1242 and Michael's Branch and approaches on US 29/64/70 & I-85 Business.Date Construction Completed: 9/5/07 Monitoring Year: (4) of 5Ecoregion: _____ 8 digit HUC unit 03040103

Rosgen Classification: _____Length of Project: 876' Urban or Rural: Urban Watershed Size: _____Monitoring DATA collected by: M. Green and J. Young Date: 2/9/11

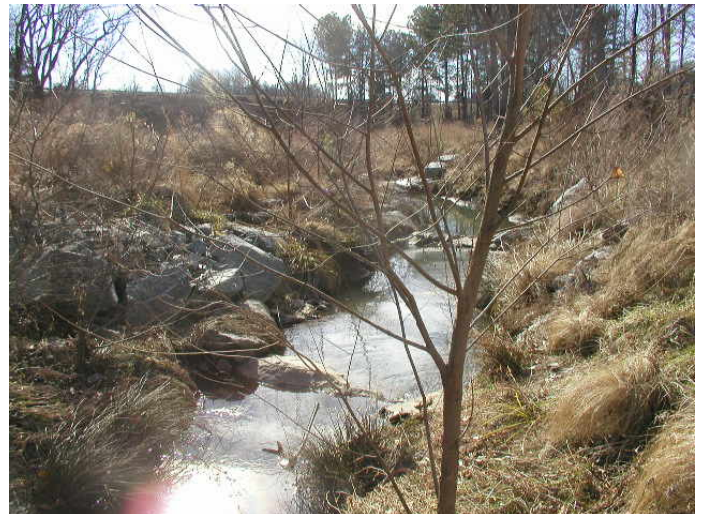
Photo Point #3 (Downstream)

The buffer downstream of Photo Point #3, on the left side of the stream had been mowed.

Estimated causes, and proposed/required remedial action: NCDOT replanted this area on 2/17/11 with yellow poplar and water oak and installed additional markers showing the line between the planted buffer and the sewer easement.

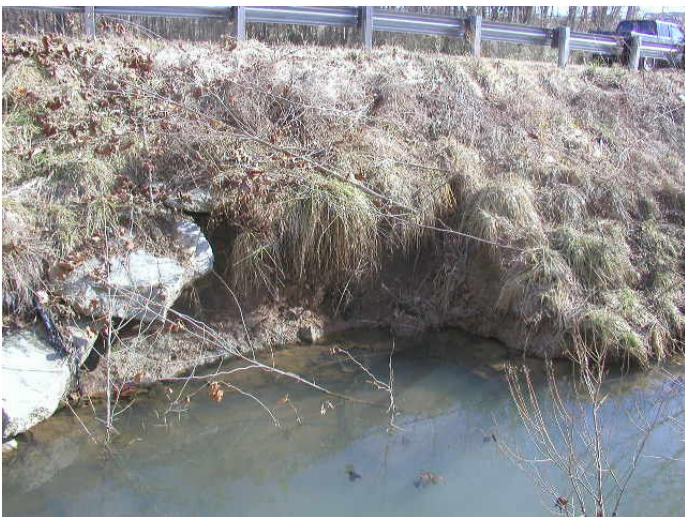
| Bank or scour erosion present? | Erosion on left bank at the end of crossvane arm | Erosion on right bank behind right crossvane arm | | | |

STA. 15+30 -Y2 - Erosion on left bank at the end of the crossvane arm located upstream of PP#1
Year 4 Winter - February 2011

Michael's Branch is stabilized for the Year 4 Winter evaluation, except for, the areas noted below. NCDOT live staked the eroded areas in March 2010 to help stabilize these areas. There was little or no change in these areas since the last evaluation. NCDOT will continue to monitor Michael's Branch.

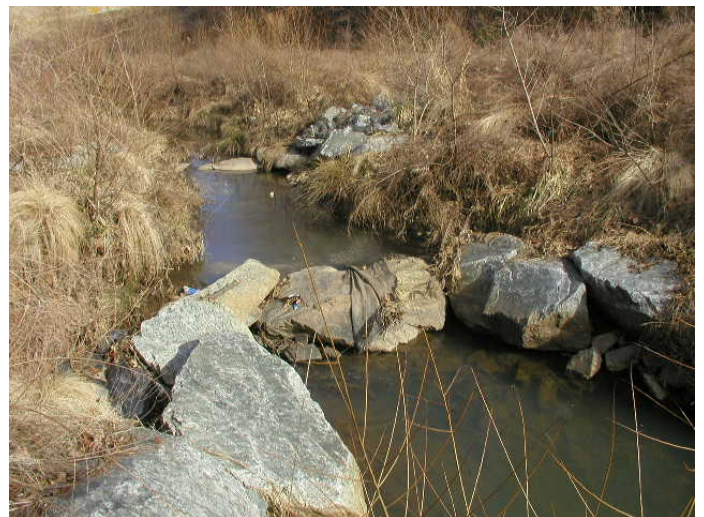
| Is water piping through or around structure? | | Water piping under crossvane | Water piping under crossvane | | |

Sta. 0+50 -Ramp C- Erosion behind right arm and water piping under crossvane located b/t PP#3 and PP#4

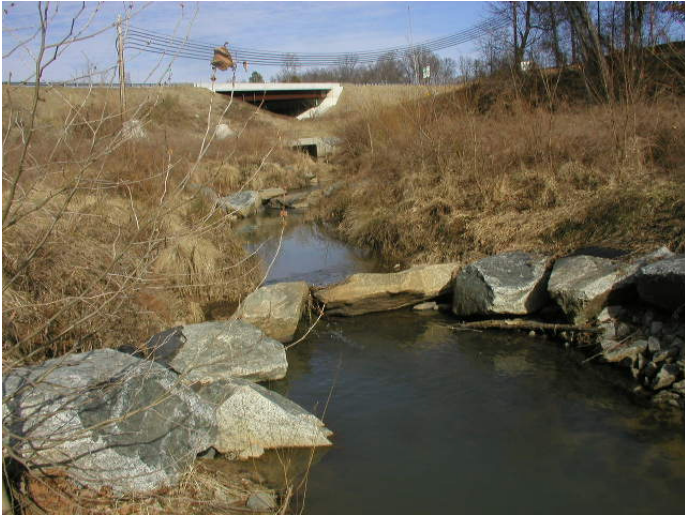
Sta. 1+00 –Ramp C- Water piping under crossvane located b/t PP#3 and PP#4
